## **Fort Leonard Wood Cantonment Landscape Context, Inventory, and Management**

Megan Weaver Tooker, Sunny Stone, and Adam Smith

September 2007

Final report

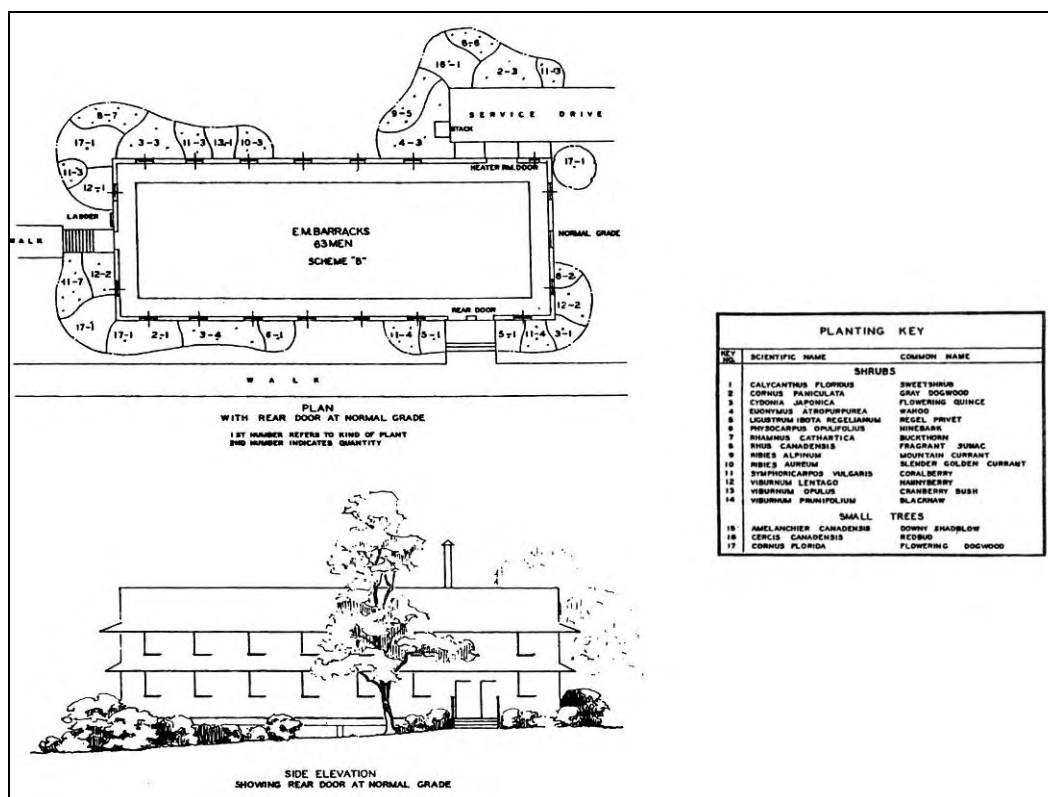
Figure 43. Example of 1941 planting plan for E.M. Barracks from Alvord, Burdick, Howson, 14 March 1941 (Robinson, 1941).

- As vegetation is lost due to age and ice storms, consider following a consistent plan for replacement. Planting plans from the 1941 report (Figure 43) show heavy planting around the barracks at the corners and building entrances. While these plans are historic, it is evident that landscaping to this degree for enlisted men's barracks was never implemented at FLW. However, many cedars trees, and a few ornamental trees and shrubs do remain at the site, so we know landscaping was important. There will need to be a balance to maintain an accurate picture of the utilitarian life at a temporary Army camp, the pride Soldiers took in beautifying their living environment, and the current needs of a museum and memorial park. A scaled down planting example follows (Figure 44).

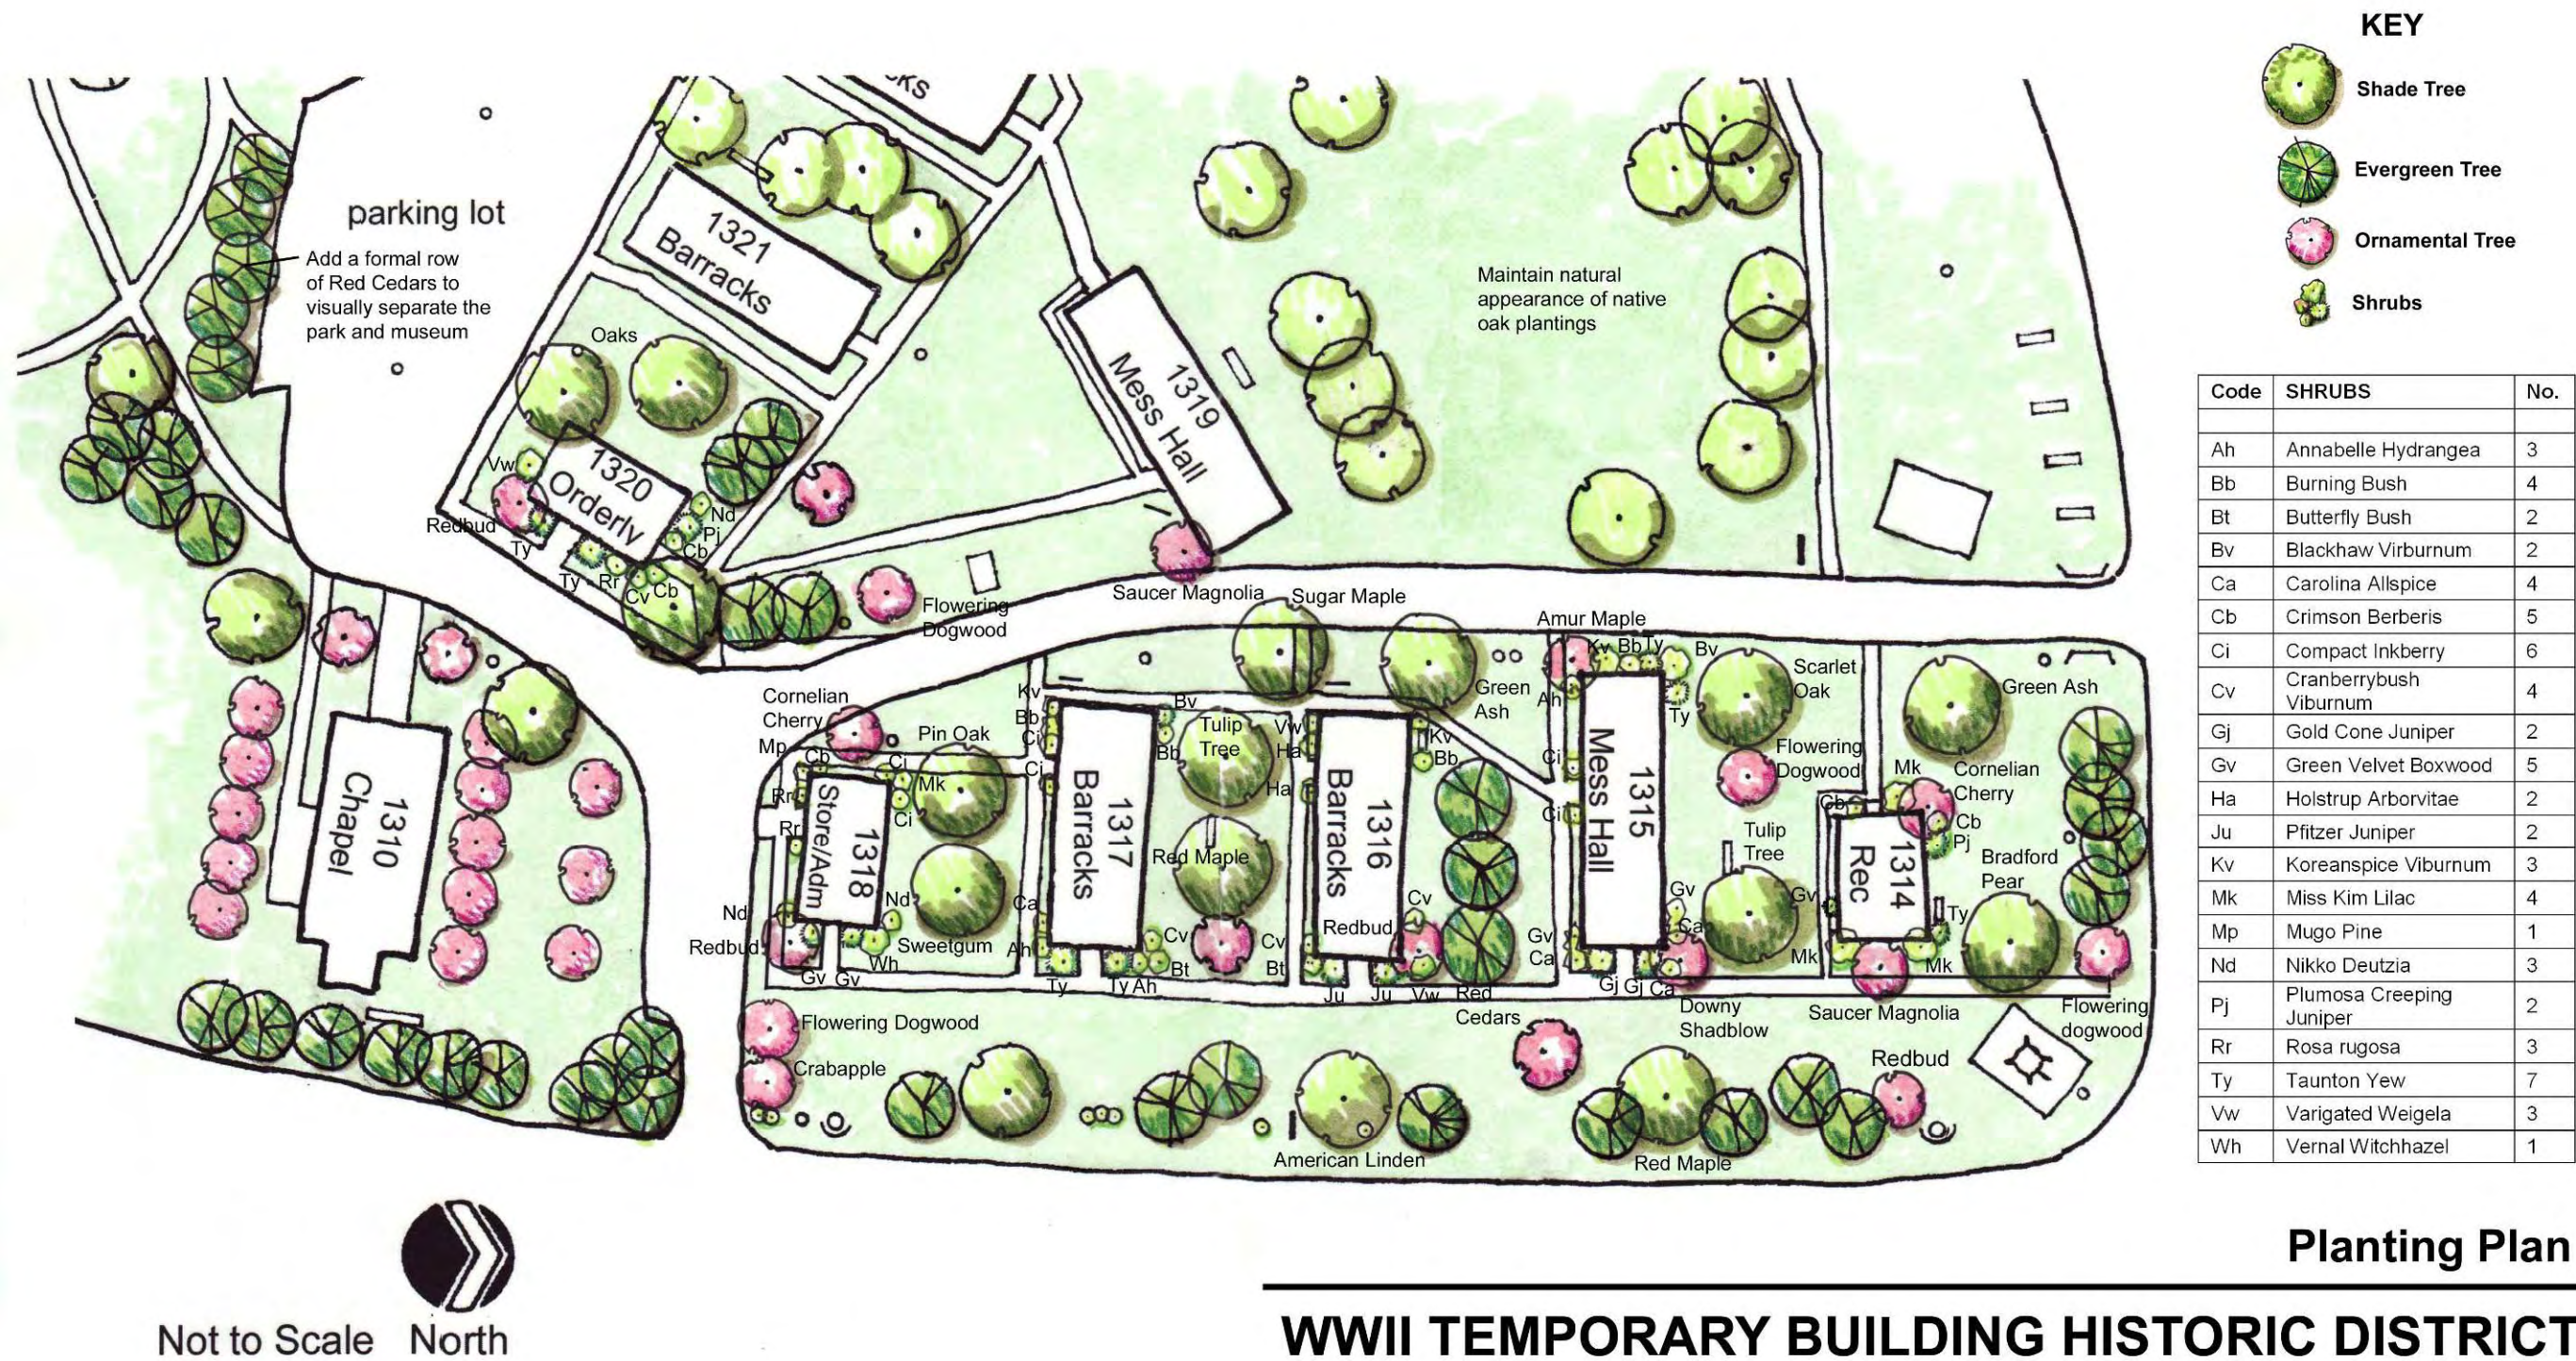
Figure 45. Proposed planting plan for WWII Temporary Building Historic District (ERDC-CERL).

- It is recommended that, as the cedar trees planted directly adjacent to buildings are lost, that they be replaced with smaller species more in scale with the buildings such as ornamental trees and shrubs of varying size. Care should be taken to not plant these ornamental trees and shrubs too close to buildings so they touch and create moisture problems. Larger shade trees and evergreens should be planted farther from the buildings where they will provide needed shade but be less of a maintenance concern (Figure 45).

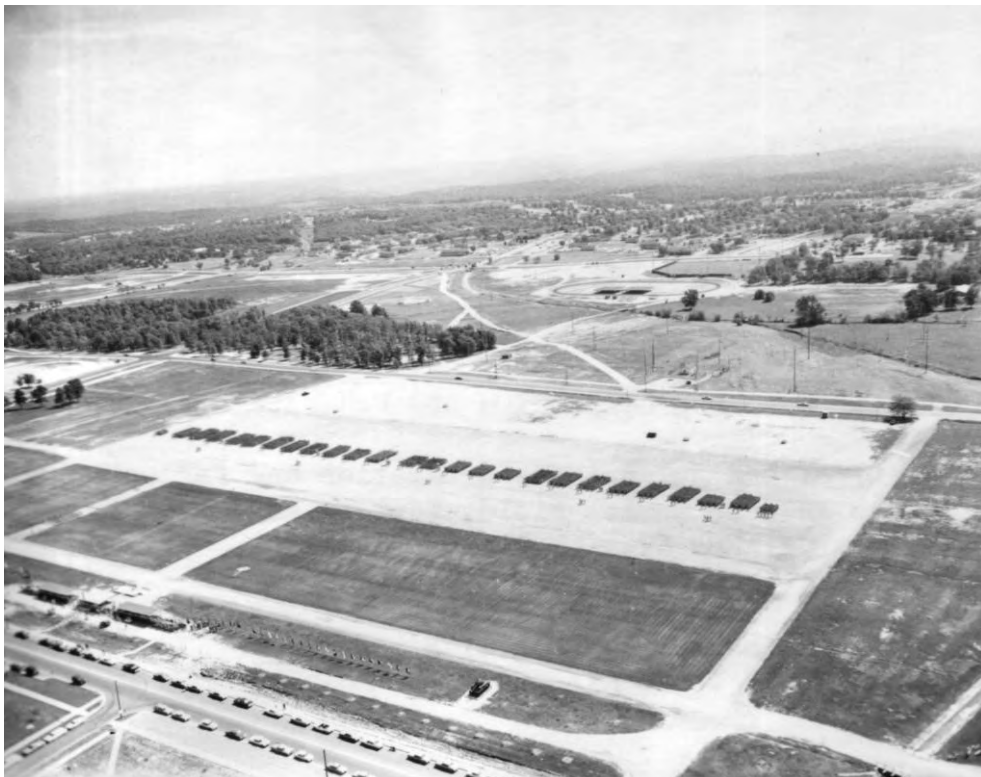
Figure 51. Aerial of the 2<sup>nd</sup> Brigade graduation and farewell review at Gammon Field, 11 May 1967 (NARA College Park, RG111-SC, box 480, photo 640 604).

Gammon Field is approximately eleven acres in size and located along Iowa Avenue in the southern half of the parade ground.<sup>52</sup> It has served as the ceremonial center of the installation since at least 1954 (Figures 47-49). Gammon Field was posthumously named in honor of Staff Sergeant Archer T. Gammon for heroics at Bastogne in January 1945. No evidence of Gammon Field was found prior to a 1954 photograph. No notations or names were found on the maps or plans from 1941 or 1946. In the 1954 photograph, one review stand is pictured with rows of folding chairs laid out on either side. Between 1954 and 1959, a concrete platform was added, complete with a narrow, white post and chain railing. By 1962, additional reviewing stands appear and the center one appears to have a stone foundation. In the 1962 and 1967 aerial images of Gammon Field, there are few if any trees present along Iowa Avenue, but visible are the formal circulation paths and formations for reviews of large numbers of Soldiers (Figures 50 and 51).

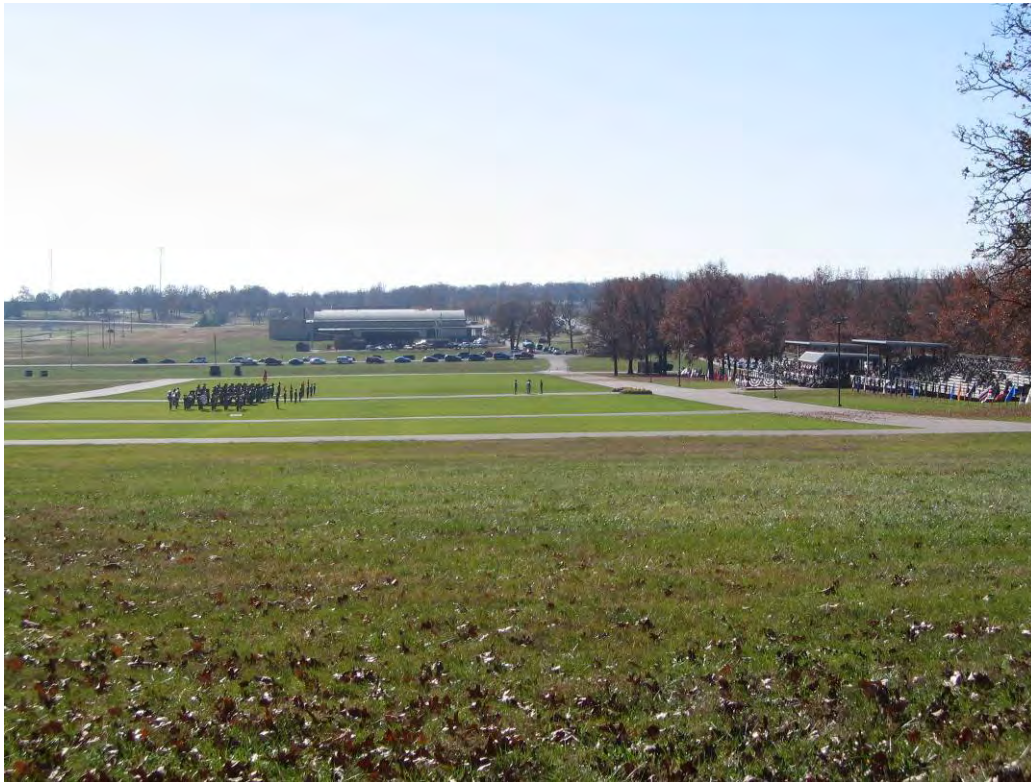
Figure 52. Looking south across parade ground from Minnesota Avenue (ERDC-CERL, 2006).

The site retains much of its integrity with the exception of the modern-looking review stands and metal bleachers (Figures 52-57). Also recently added, is the row of Pin Oak trees along Iowa Avenue. This formal row of trees is not visible in the 1963 and 1967 aerial images of Gammon Field. While they are not historic, they are listed as a compatible feature. They lend an element of formality to the ceremonial landscape and serve to shield ceremonies from the traffic and views of parked cars along Iowa Avenue. The expansive, new PX, located to the north of Gammon Field, does not detract from the integrity due to a rise in topography between the PX and Gammon Field (see Figure 56).

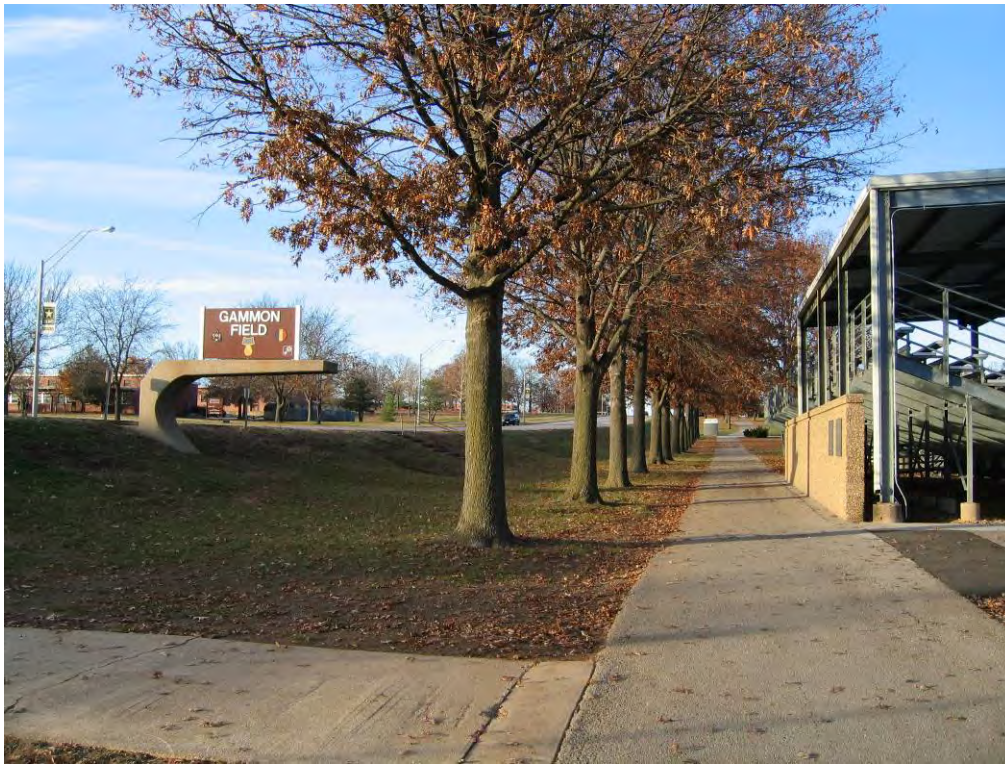
Figure 53. Looking north along Iowa Avenue (ERDC-CERL, 2006).

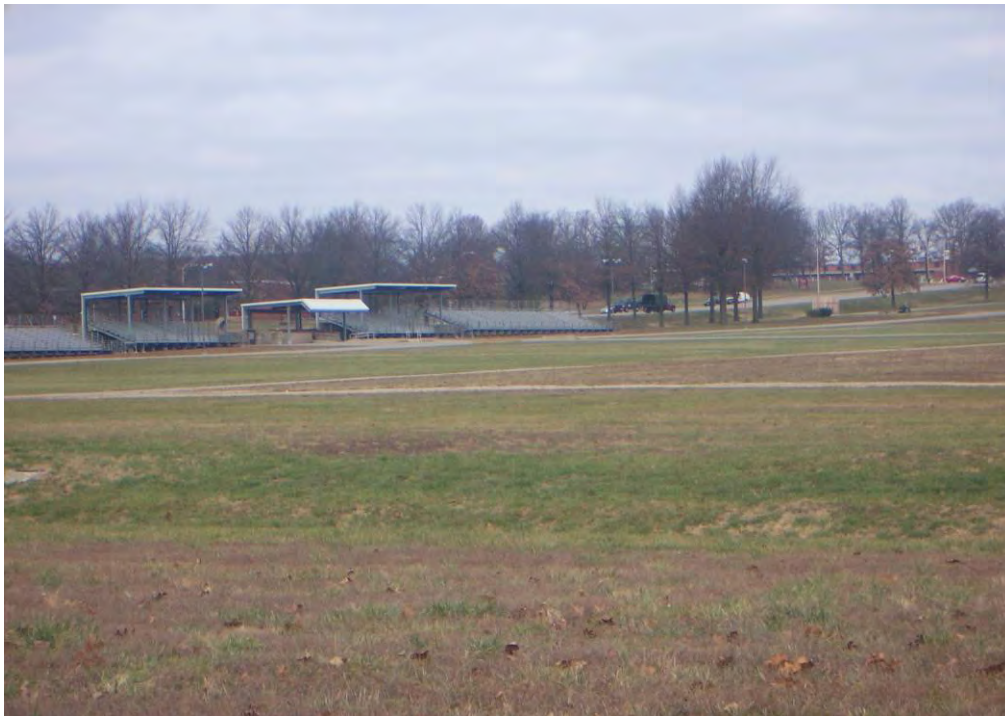
Figure 54. Looking west across Gammon Field from training areas (ERDC-CERL, 2005).

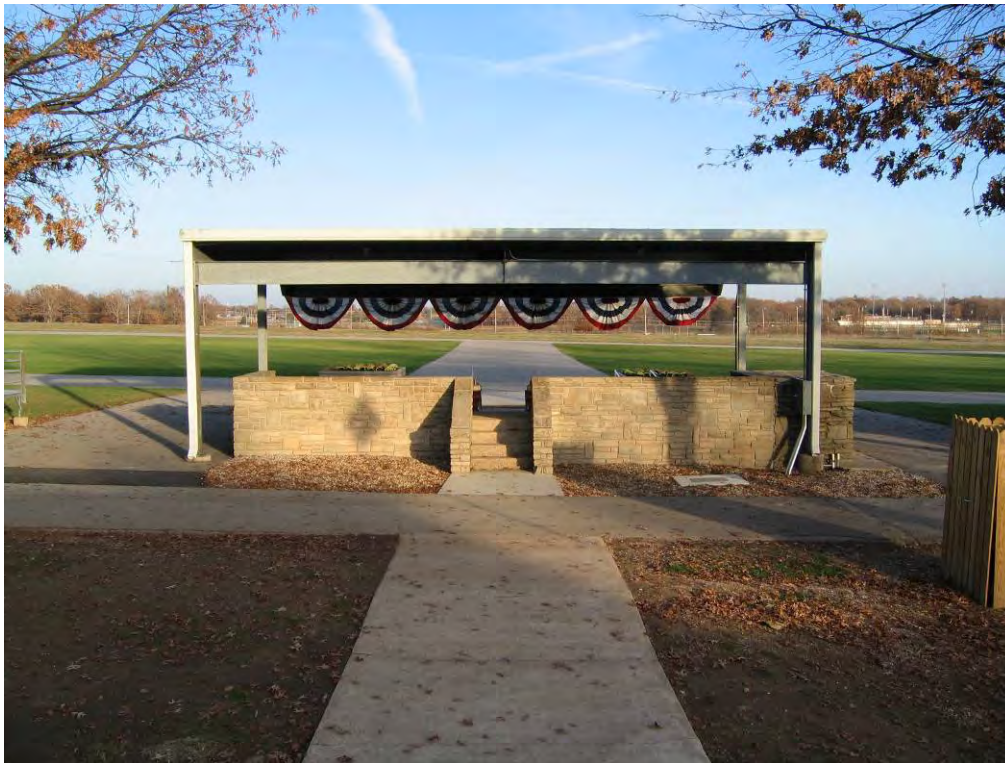
Figure 55. Looking east at rear of center reviewing stand and across Gammon Field (ERDC-CERL, 2006).

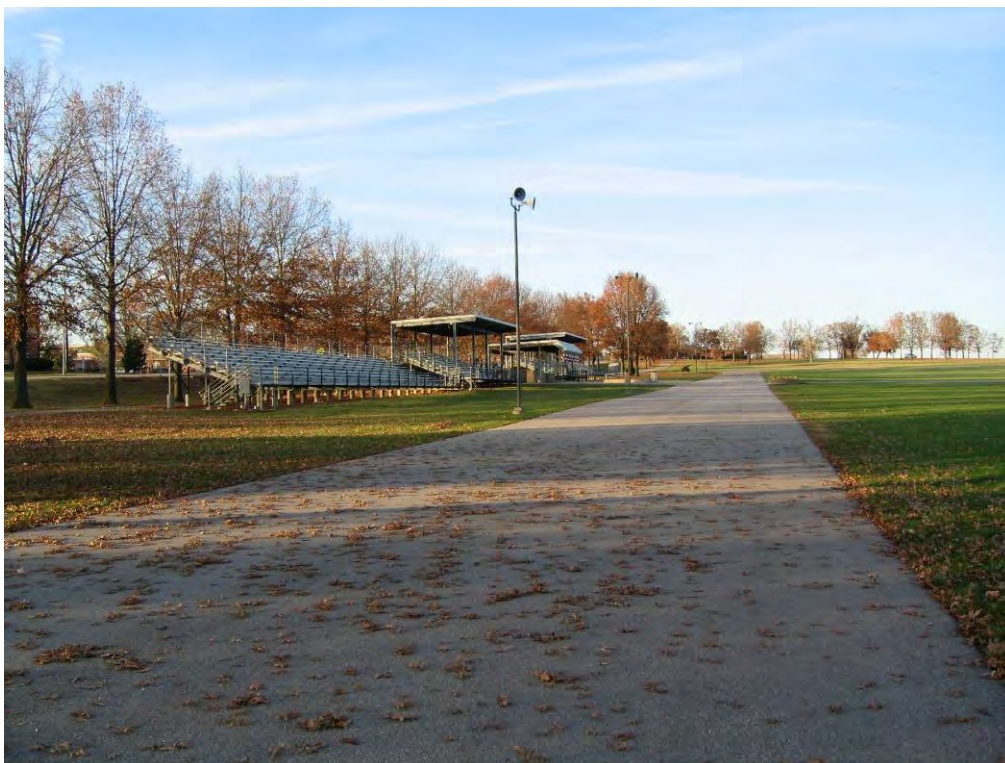
Figure 56. View of Gammon Field looking north toward new PX (ERDC-CERL, 2006).

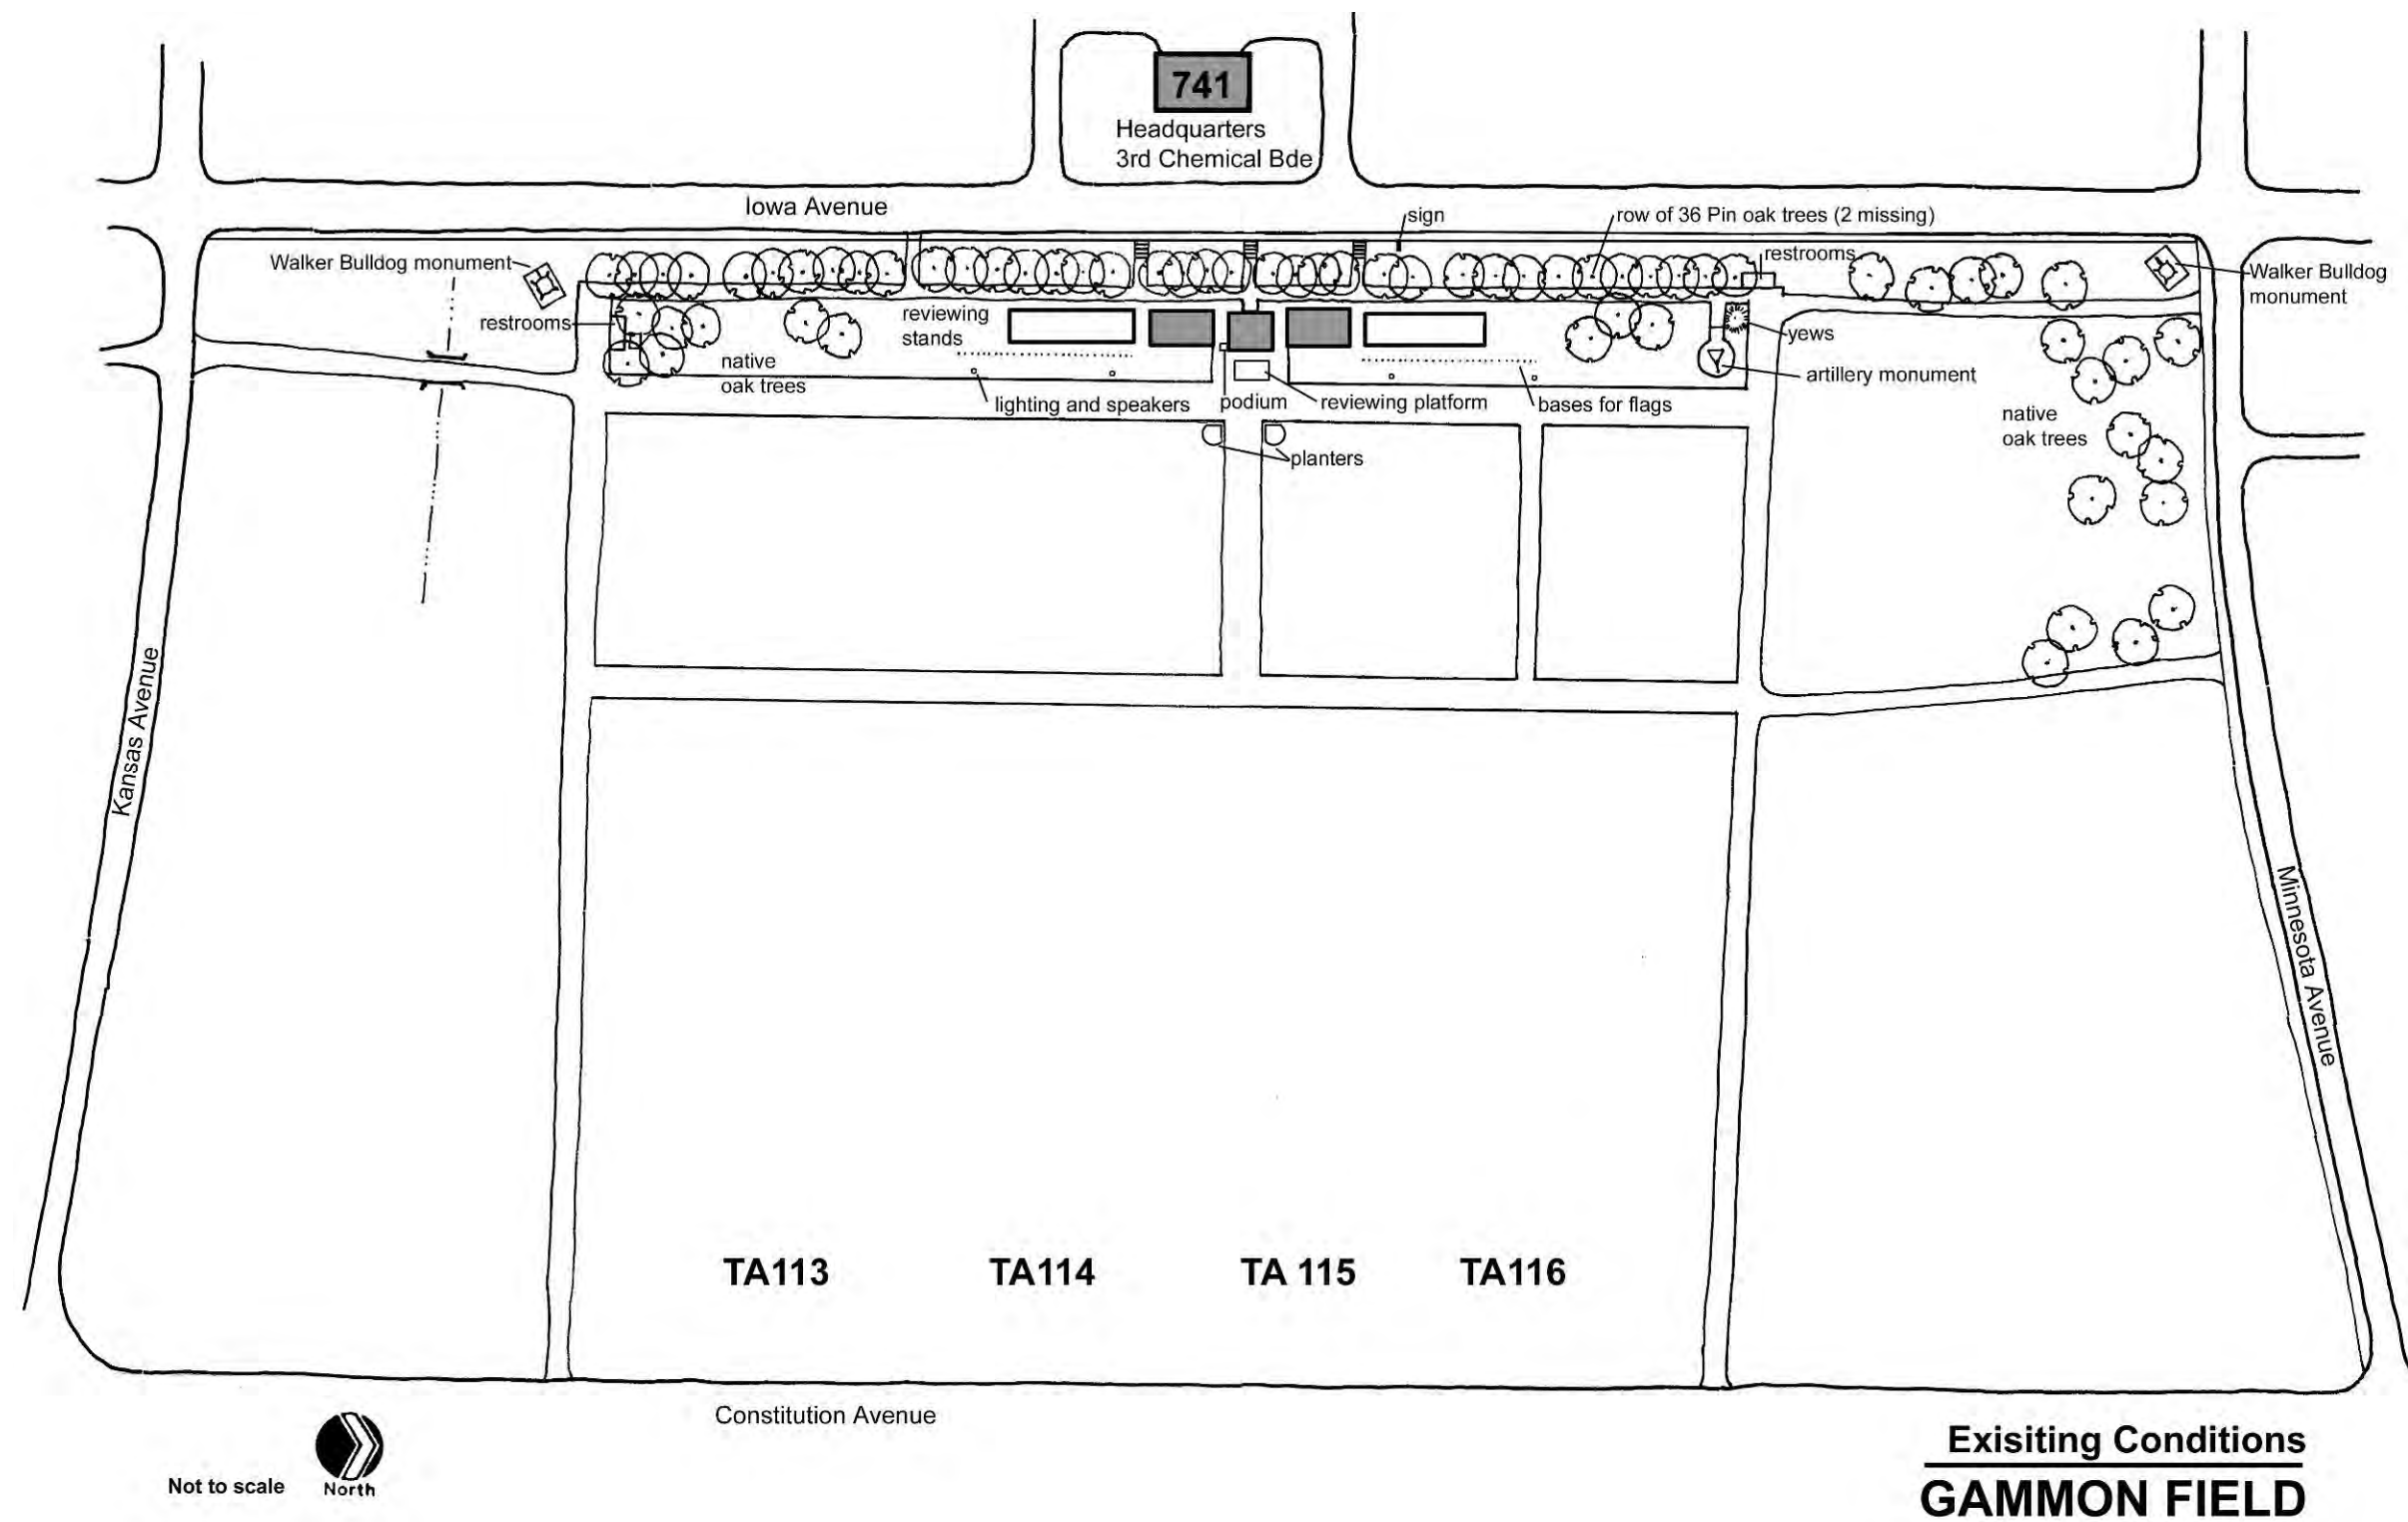
Figure 57. Gammon Field existing conditions (ERDC-CERL, 2006).

Metal bleachers, metal roofs of reviewing stands, modern lighting, and speakers.

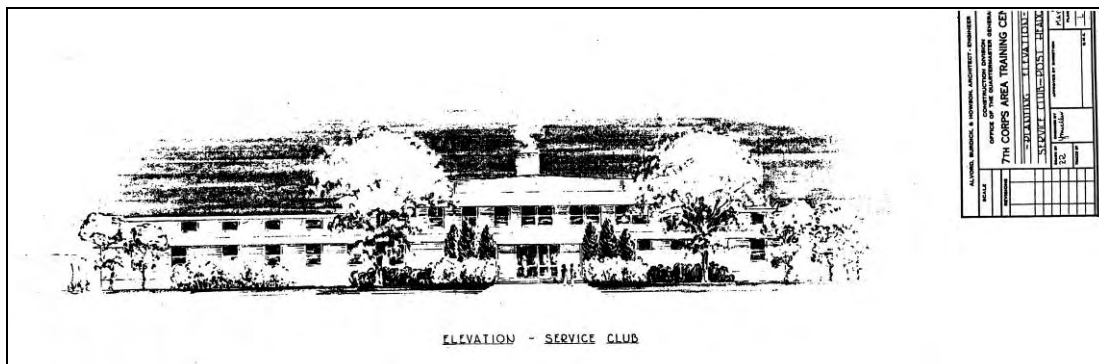
Figure 58. Elevation of planting plan for Service Club across from Post Headquarters (Robinson, *Landscape Development Plan*, 1941).

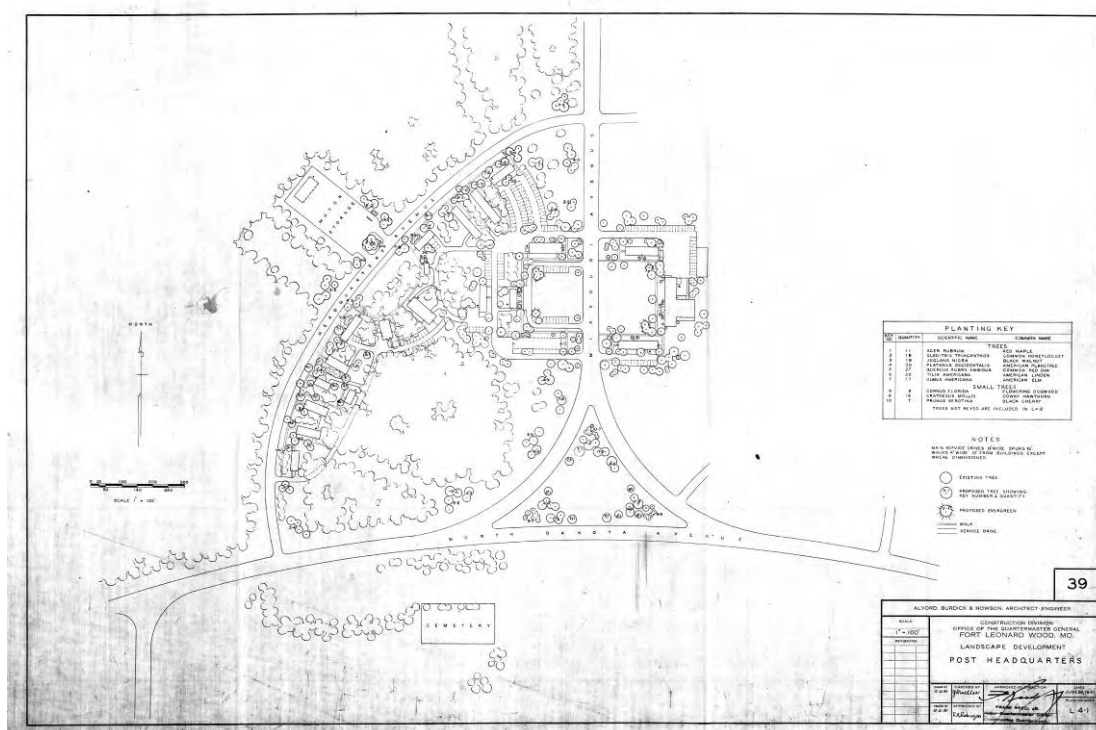
Figure 59. Landscape Development plan for post headquarters, Alvord, Burdick and Howson, Architect Engineer, 24 June 1941 (courtesy, USAES History Office, FLW).

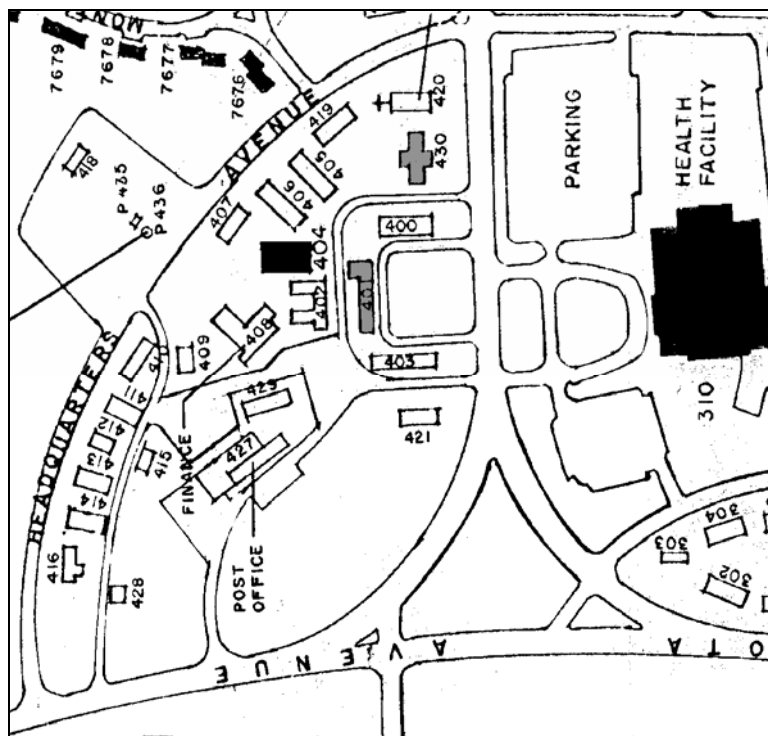
Figure 60. Diagram of Post Headquarters and Red Cross buildings as built from 1968 map (courtesy, USAES History Office, FLW).

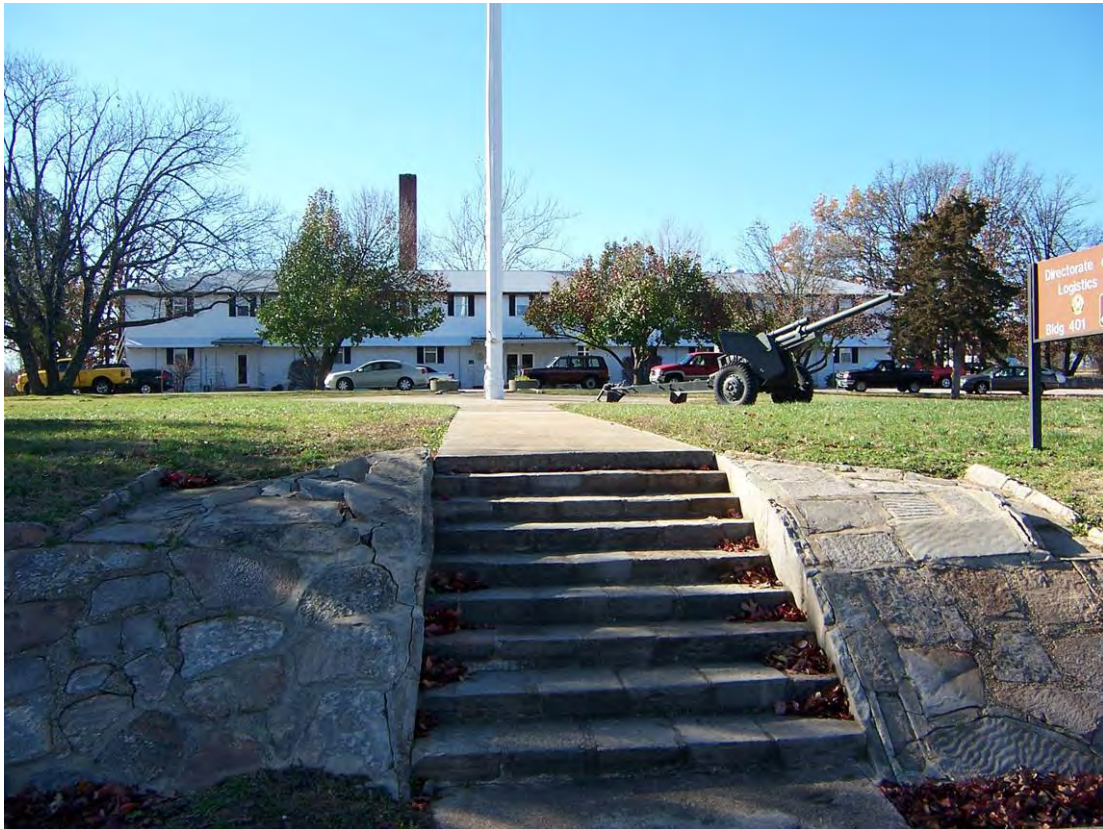
Figure 65. Photograph of POW stonework and Old Post Headquarters (ERDC-CERL, 2005).

The formal, focal landscape in front of the Old Post Headquarters and Red Cross buildings is a significant component of the historic WWII Mobilization cantonment (Figures 65 and 66). The buildings were laid out and grouped as to convey the impression of importance and that is still visible today. The POW stonework that surrounds the buildings is significant for its cultural heritage and mark it left of the landscape. The prominent site, located near the entrance to FLW with significant views to the parade field, is the same today (Figure 67).

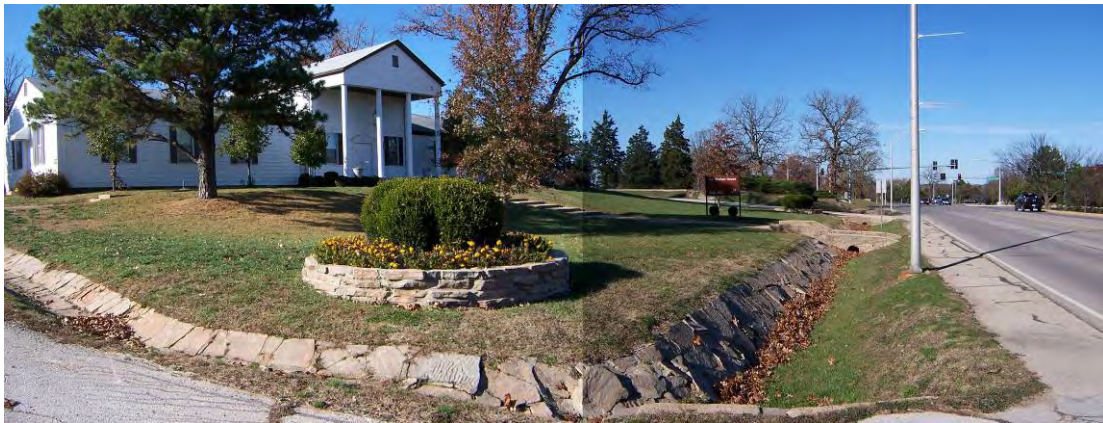
Figure 66. Photograph of POW stonework and Old Red Cross Building (ERDC-CERL, 2005).

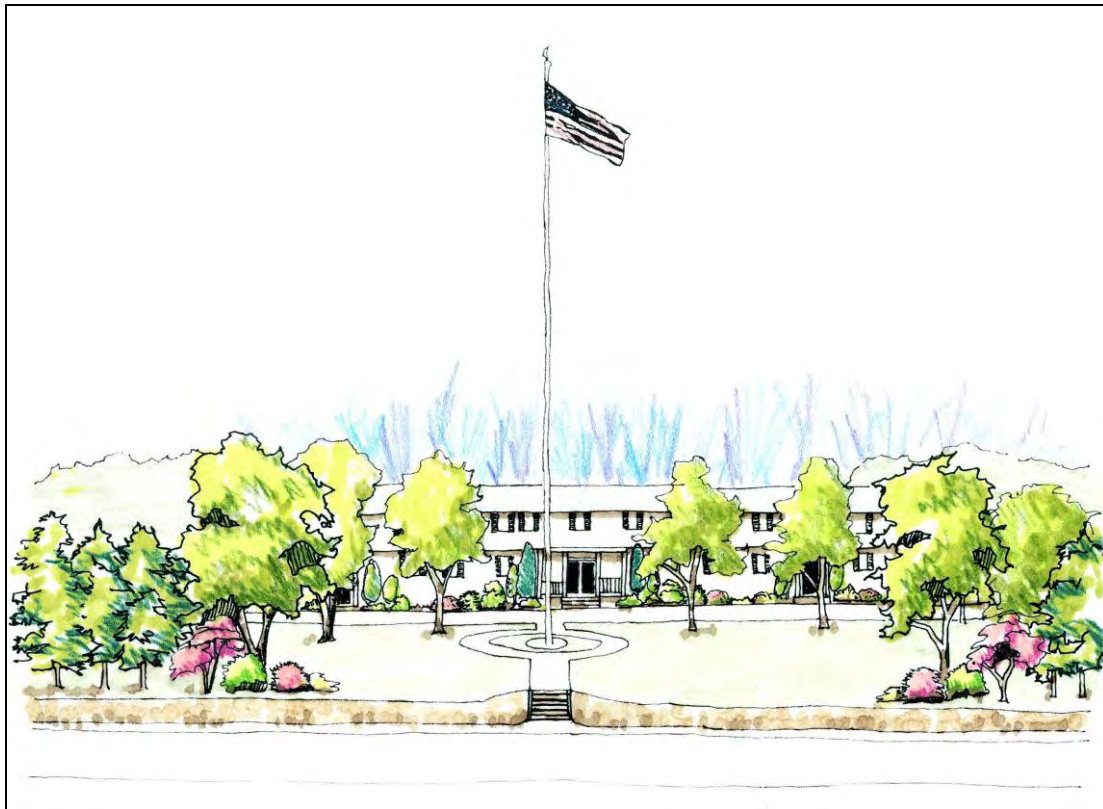
Figure 69. Drawing of proposed changes to existing landscape at the Old Post Headquarters (ERDC-CERL).

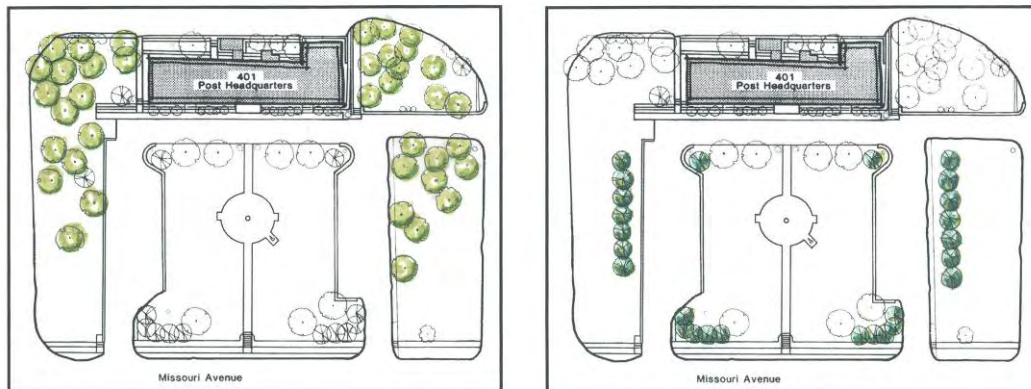
Figure 70. Diagrams depicting two design ideas for the empty lots north and south of the Old Post Headquarters. On the left, extending existing native oak plantings, and on the right, planting two formal rows of evergreens where the buildings stood.

- Diagrams are included below with two design possibilities for planting the open lawn areas north and south of the Old Post Headquarters (former sites of buildings 400 and 403) (see Figure 70). The first design idea depicts gently extending the native oak plantings from the north and south sides of the building to the two lawn areas to frame the formal center lawn area. The second design depicts a formal row of trees, like Eastern red cedar, along the edge of the site both to frame the formal landscape of the Old Post Headquarters front lawn area and in keeping with the architecture that once stood there.
